PROJECT: Midnite Mine Remediation

REPORT NO: 2019-020

Summary of Work Activities or Events for this reporting period:

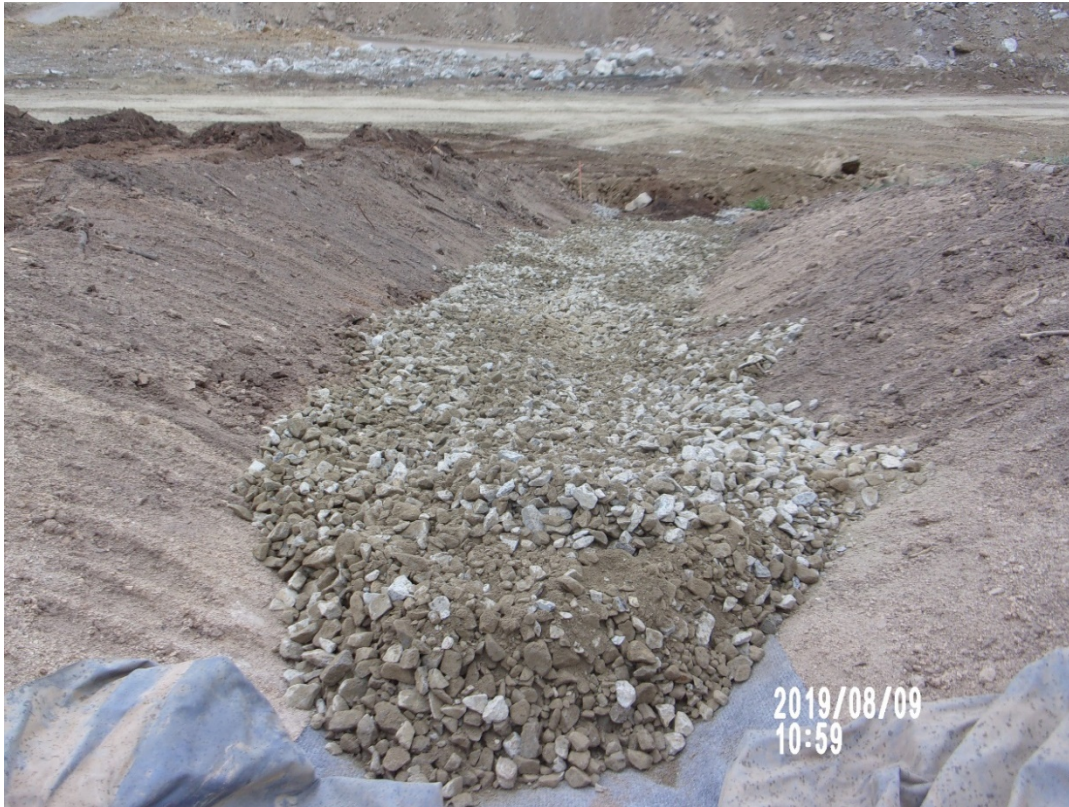
Figure 1 – GCL and drain gravel installed in the Finger 1 IC looking east.

- Backfilled around and plumbed the Pit 4 vertical pump risers.
- Extended placement of Geocomposite Clay Liner (GCL) and Drain Gravel in Finger 1 of the Infiltration Collectors on the west side of Pit 4.

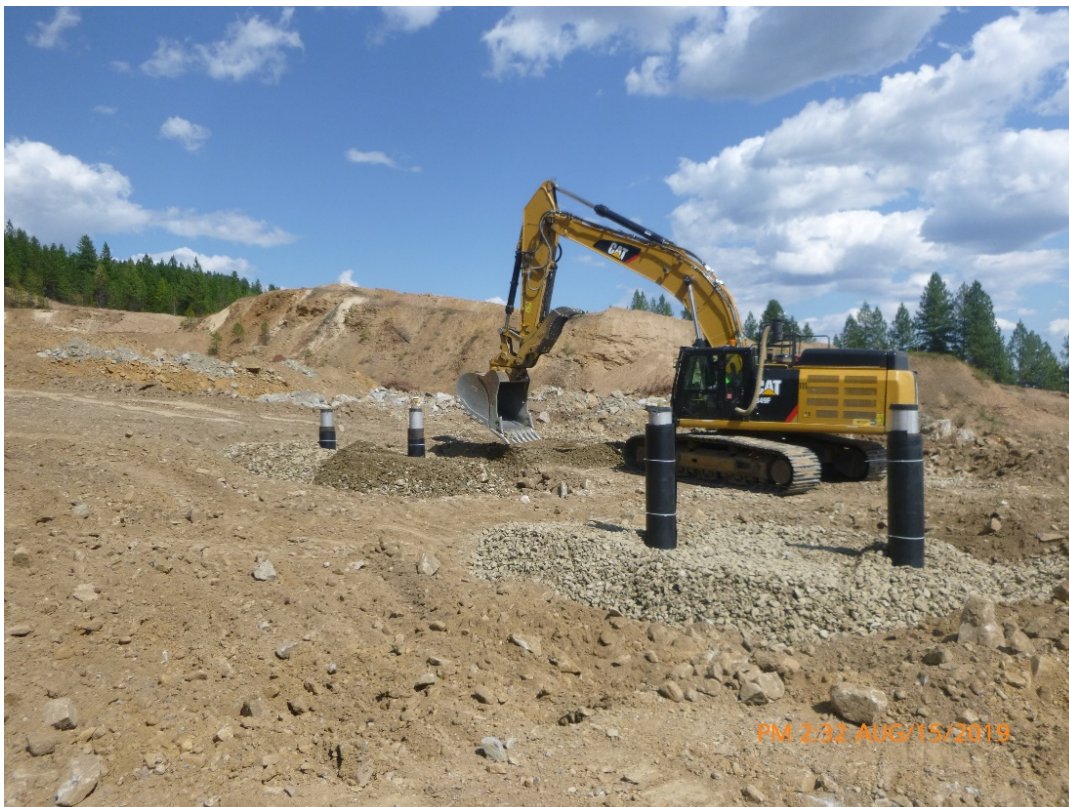
Figure 2 – 349 excavator placing drain gravel while leveling near the south UDS riser.

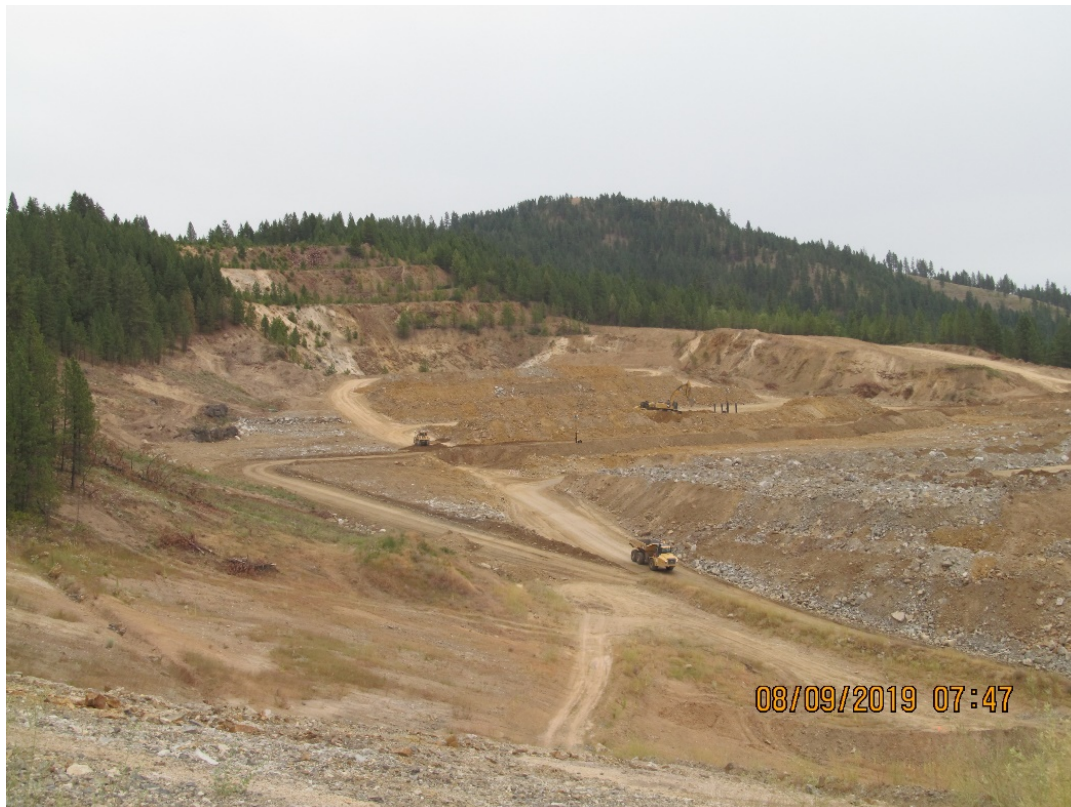
Figure 3 – View of Pit 4 from the southwest

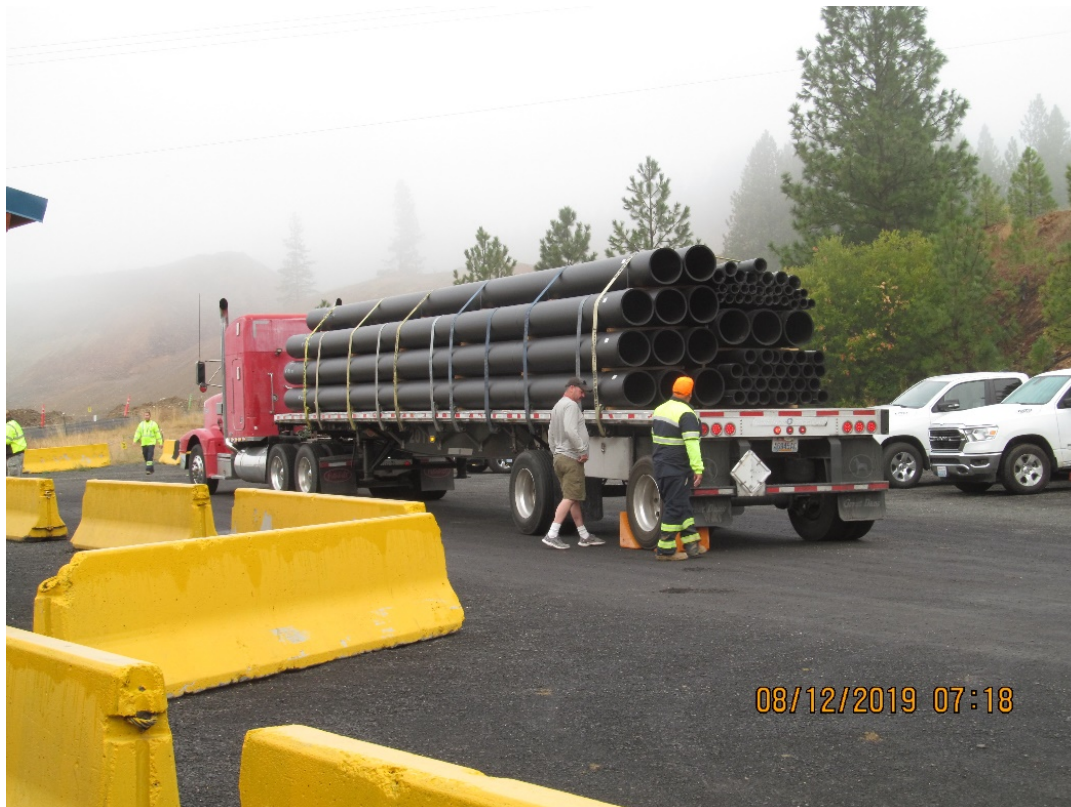
Figure 4 – HDPE pipe delivery for the South Pond. Note that dust monitors were not operated on August 12 due to the fog shown in the photo.

- 16", 6", and 4" HDPE pipe for the South Pond was received on August 12
- Road surface coarse was delivered from the Copenhaver pit in Reardan, WA for repairs to the East Access Road.

There were no excavating and hauling activities on Monday (8/12/2019) due to the amount of rain received on Site (0.33 inches) the previous day. The truck operators were sent home for the day and the samplers were turned off.
